Memorandum

Re: Post-TCRA Quarterly Inspection Report – January 2017

This memorandum reports the results of the January 2017 inspections of the armored cap cover, fencing, signage, buoys, and security cameras installed for the Time Critical Removal Action (TCRA) at the San Jacinto River Waste Pits Superfund Site (TCRA Site).

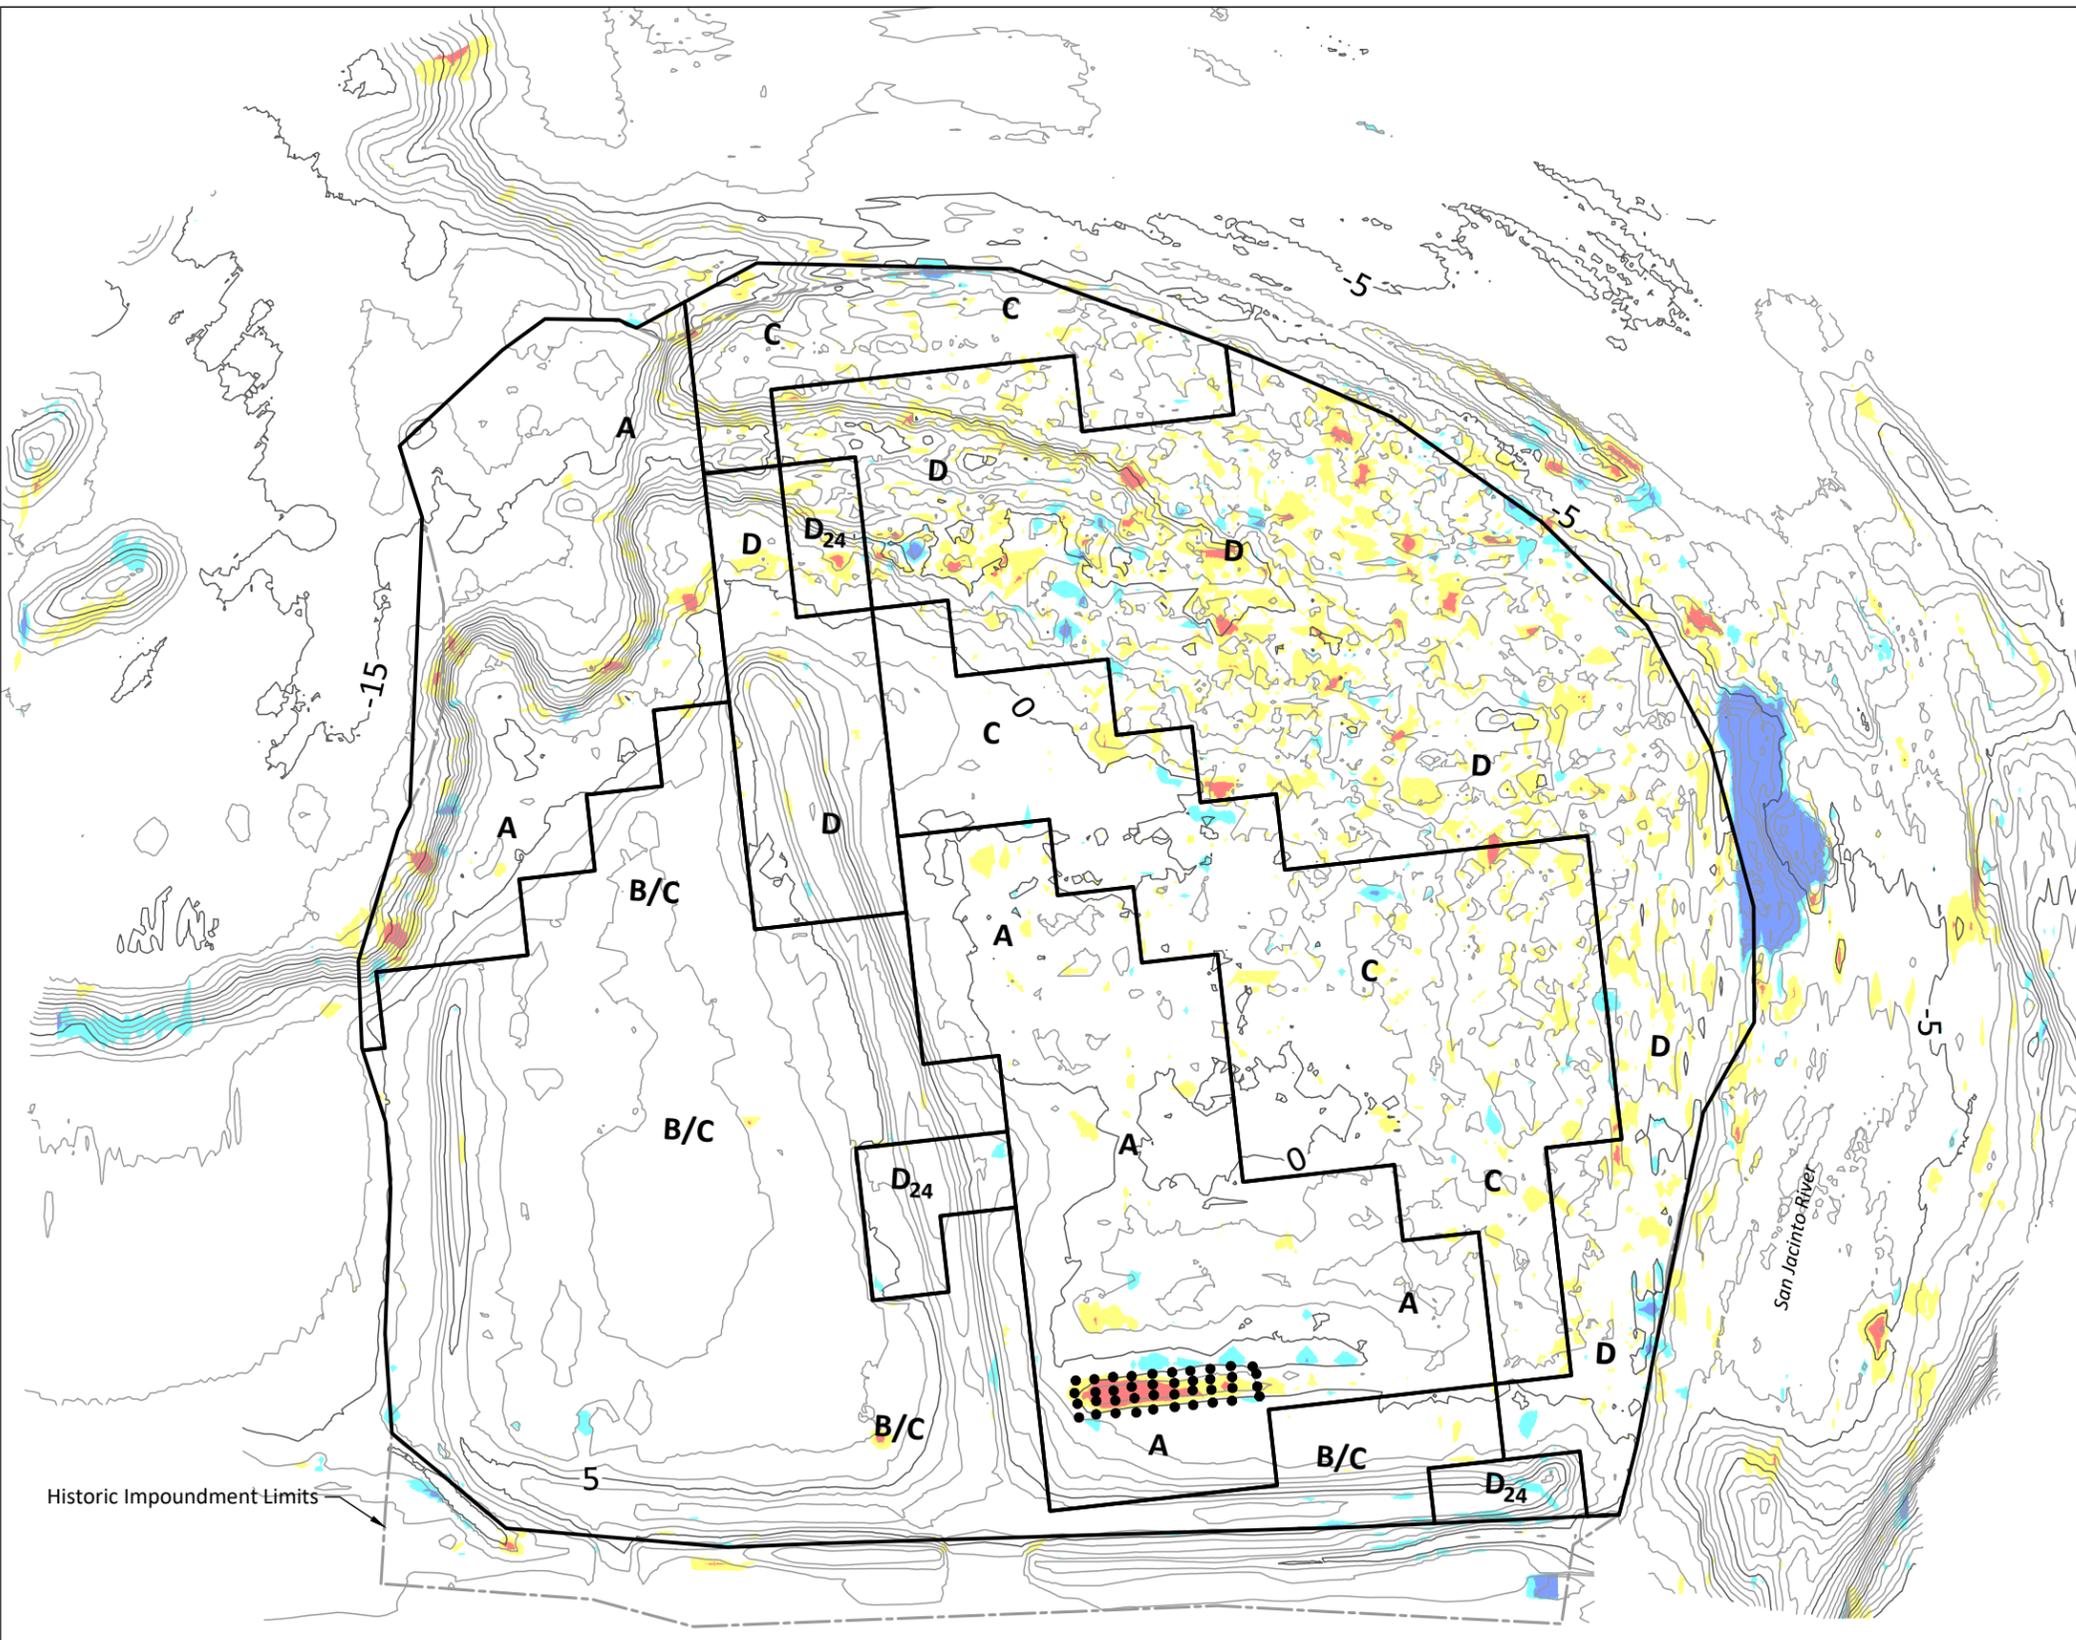
One contiguous area of significant elevation change in the Eastern Cell, shown on Figure 3, was covered in water during the visual inspection that occurred on January 23, 2016. The net elevation changes observed between the July 2016 – October 2016 and the October 2016 – January 2017 surveys in this area were minimal; however, because of the contiguous nature of the degree of elevation change in this area, the Respondents manually probed the area on February 3, 2017. The probing proceeded along four transects spaced equally across the area. The locations of the transects are shown on Figure 3. The probing indicated there was up to 6 inches of silt overlying the

cap, but the underlying cap was intact and cemented by biological growth and mineral precipitation. No maintenance was necessary. The elevation change in the area identified is attributed to gradual buildup of silt on the armored cap over time and removal of a portion of that silt between the October 2016 and January 2017 surveys of the cap. As mentioned before, it is likely the silt washed away during a high-flow event that occurred between the October 2016 and January 2017 survey. There was no evidence of movement of actual cap materials.

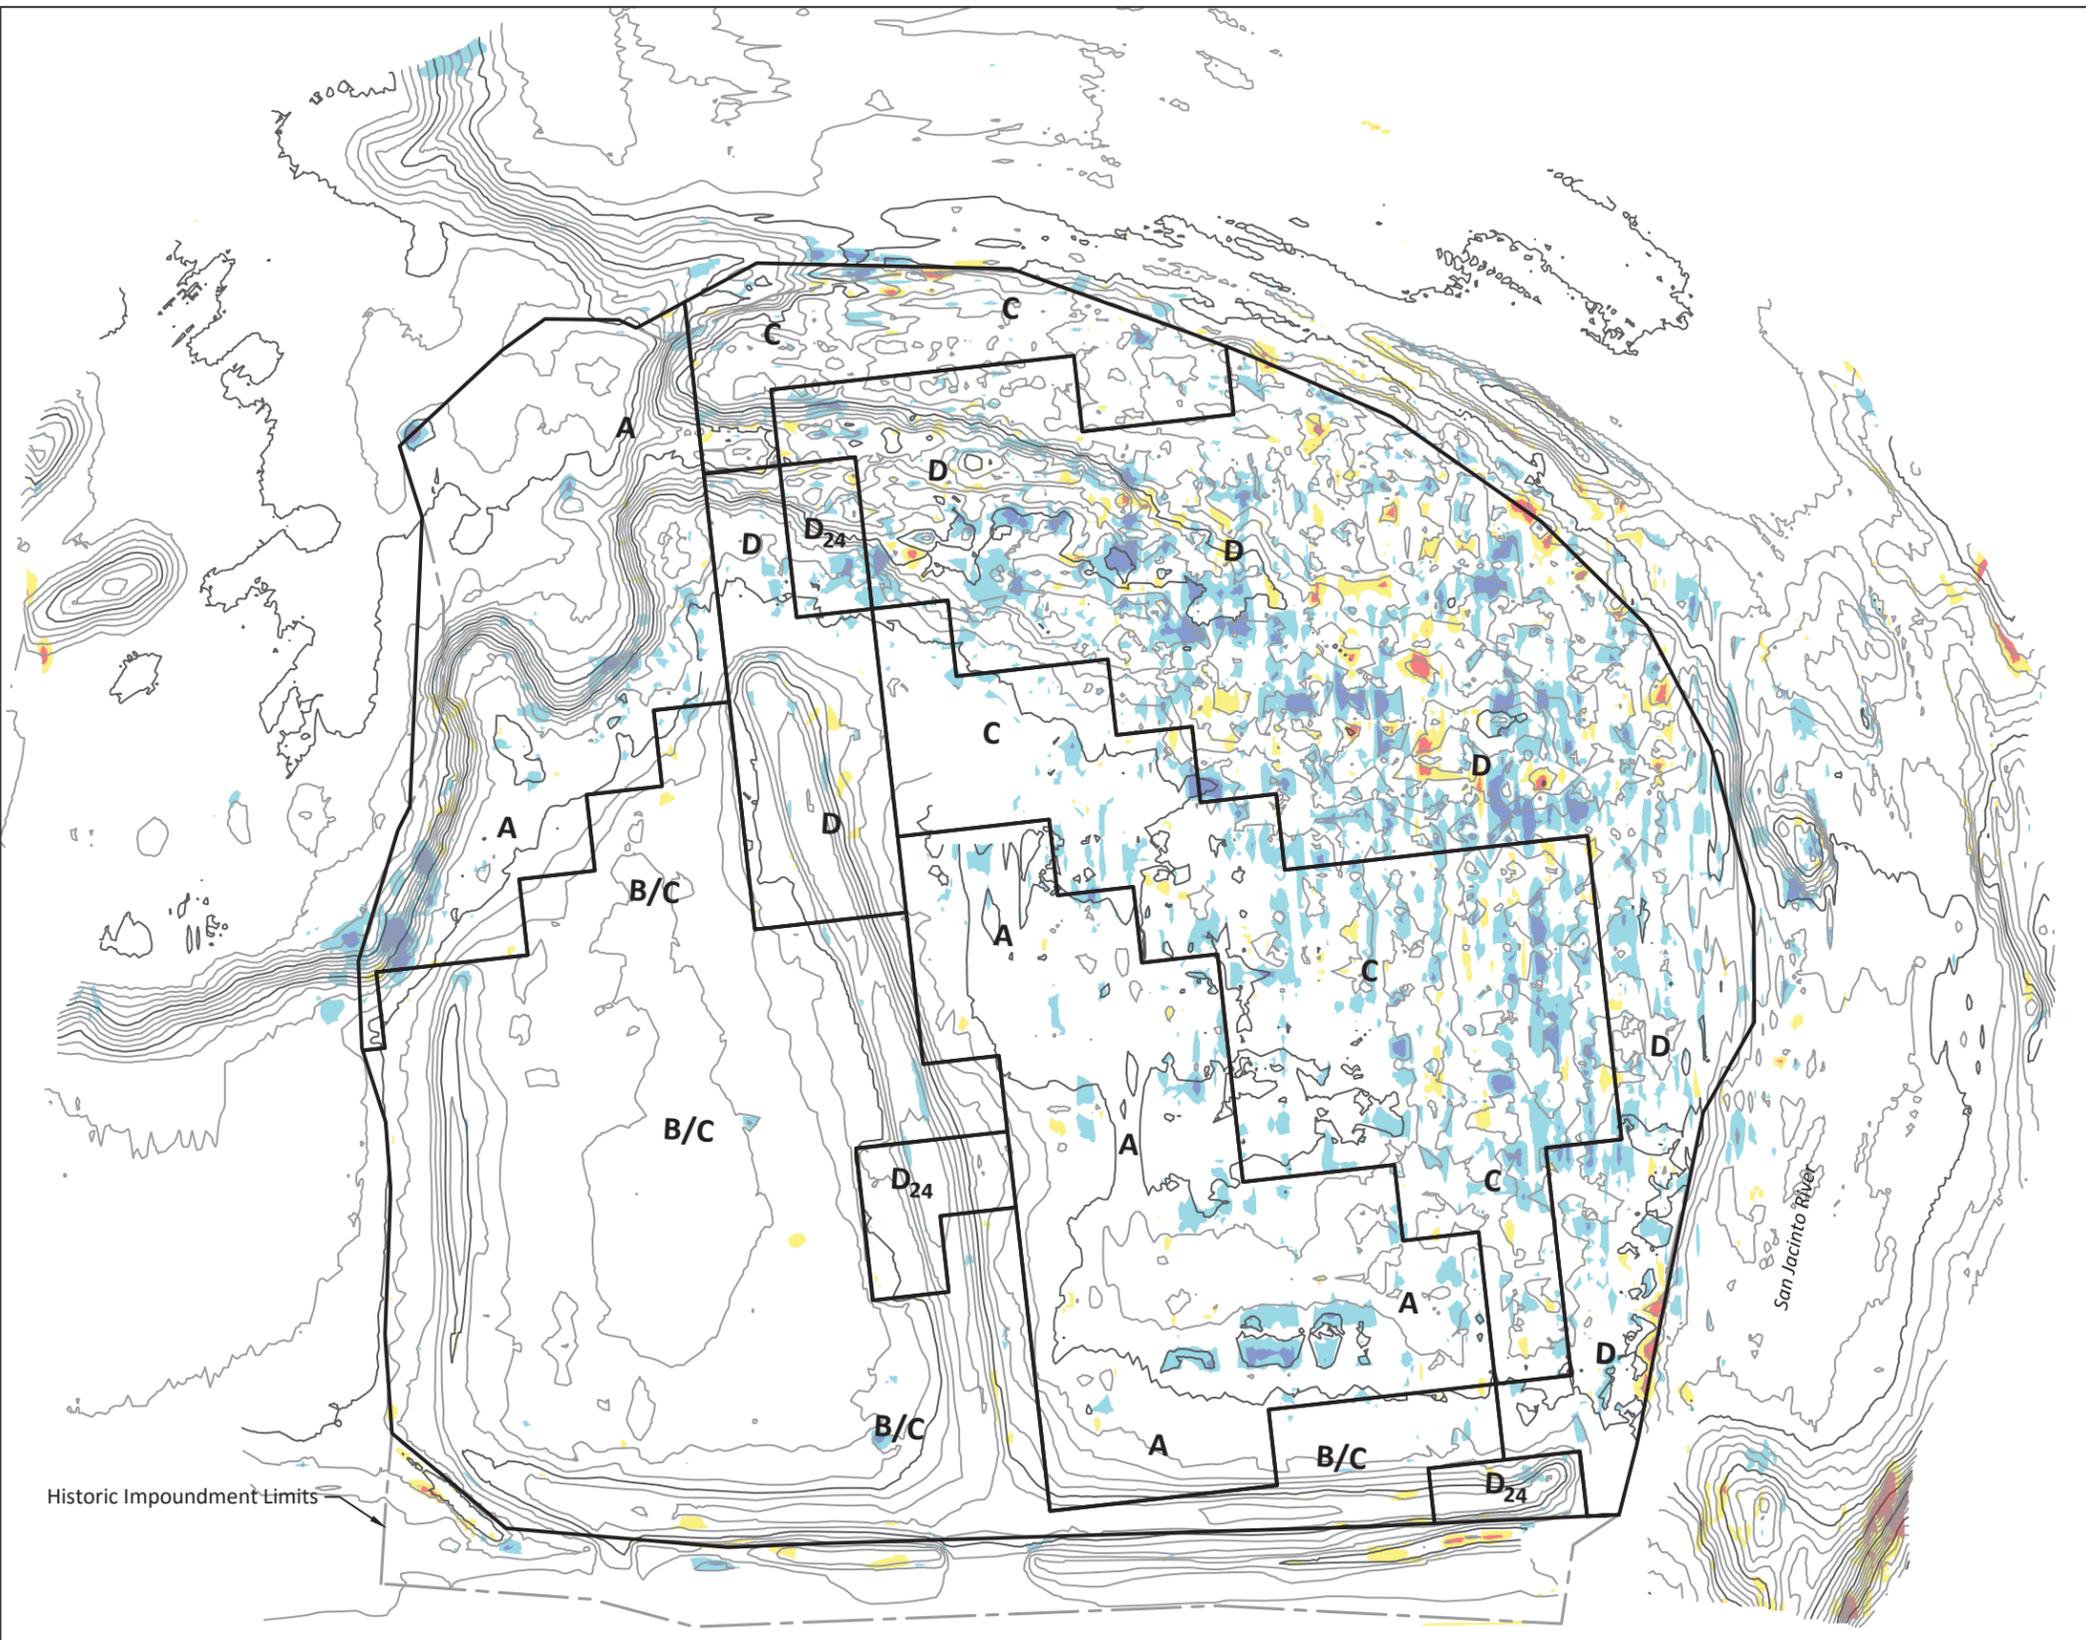
Figure 4 shows the survey results for the October 2016 quarterly inspection. The light and dark blue areas on this figure indicate there was a significant amount of sediment deposition that occurred in the period between the July 2016 and October 2016 quarterly inspections. The elevation changes seen in the January 2017 survey compared to the October 2016 survey (Figure 3) are likely due to transport and removal of fine-grained material that had deposited on the cap in the previous quarter during a high flow event or events.

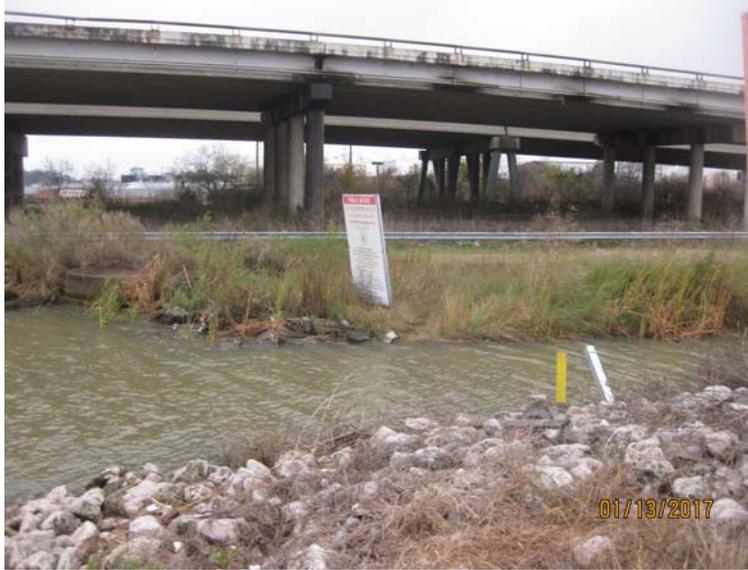
Photograph 01: USEPA Public Notice Sign located near southern berm (view south-west)

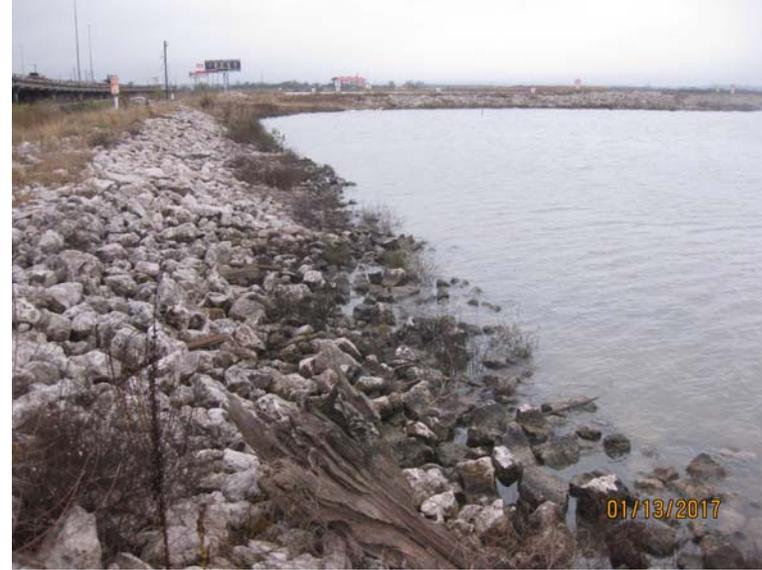
Photograph 02: Southern berm and Eastern Cell (view west)

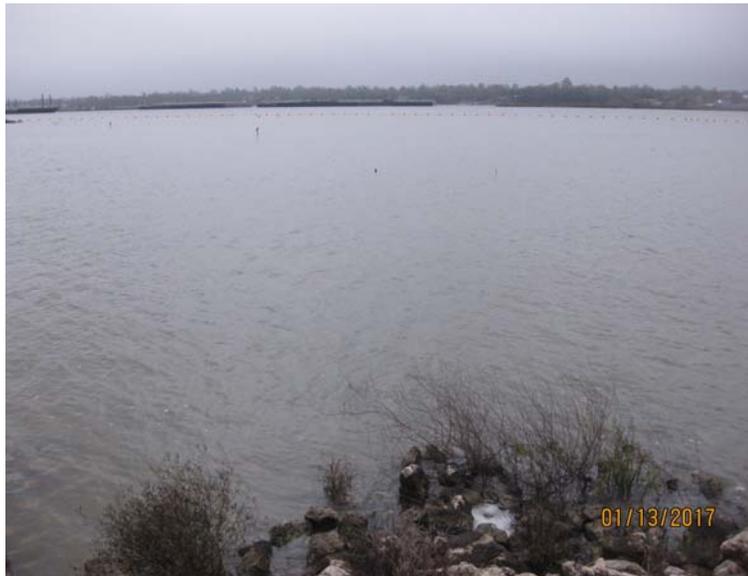
Photograph 03: Eastern Cell (view north)

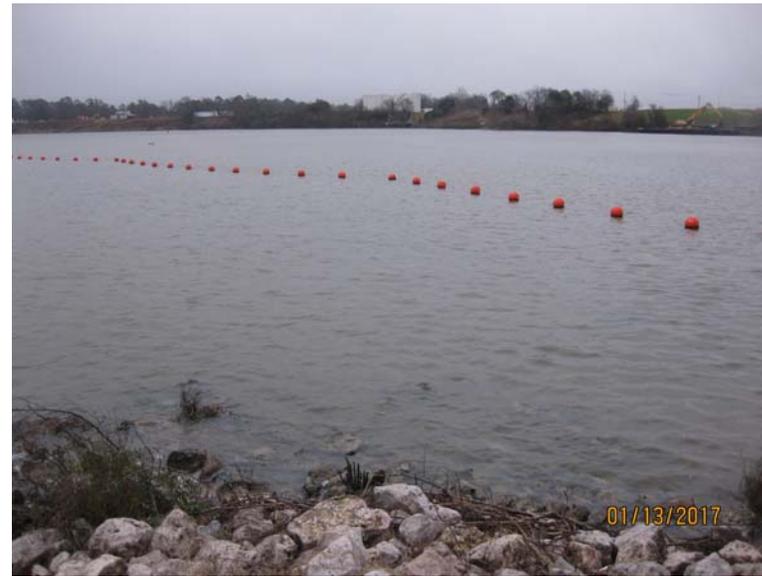
Photograph 04: Warning buoys along eastern edge located along Eastern Cell (view northeast)

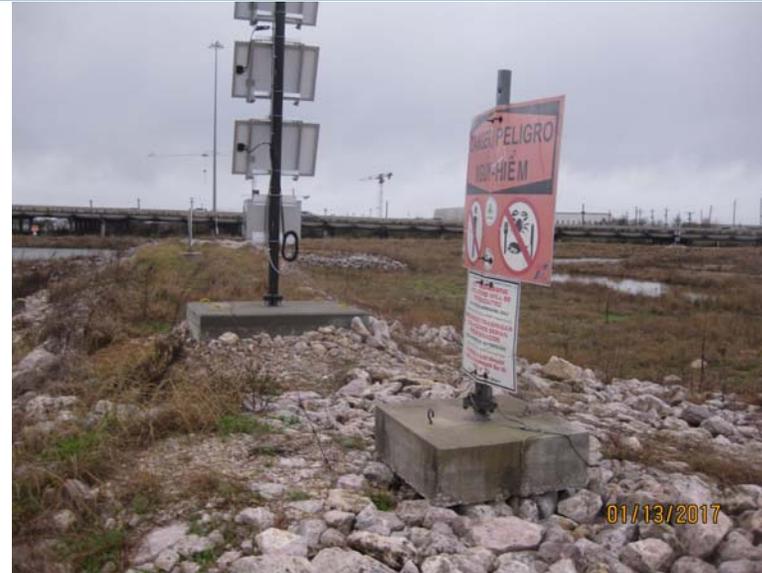
Photograph 06: Warning sign located along central berm (view southwest)

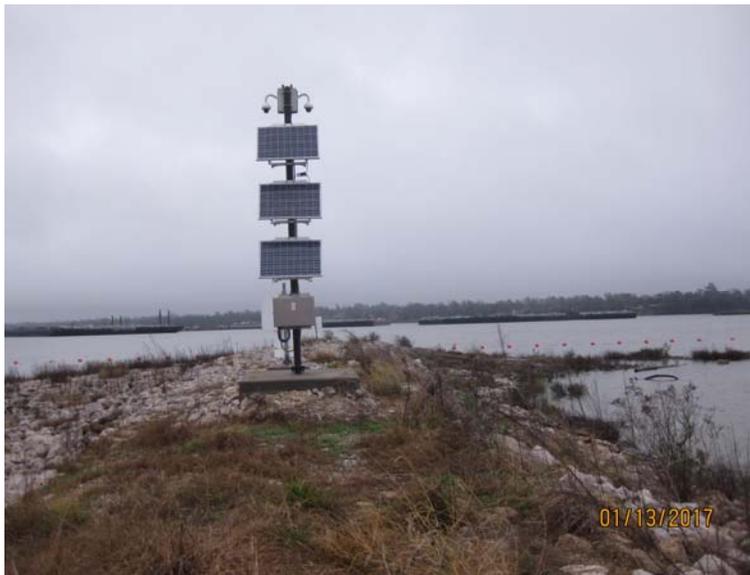
Photograph 07: Security camera system located along central berm (view north)

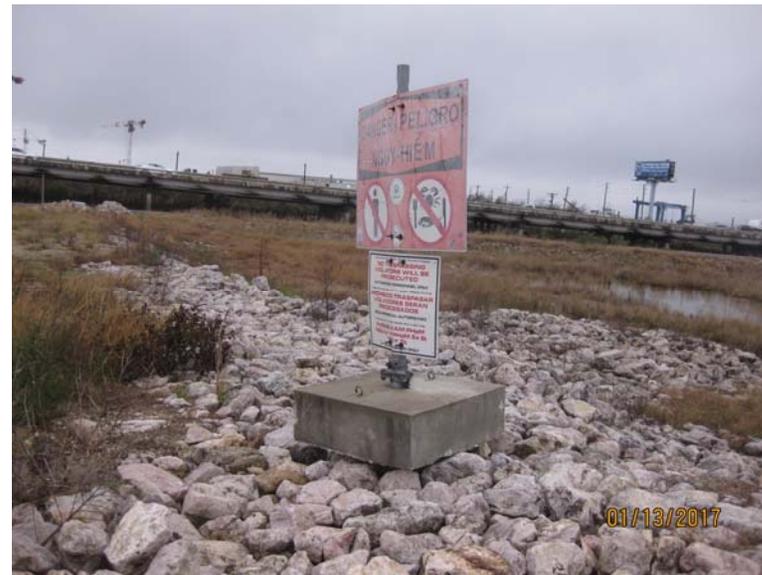
Photograph 08: Warning sign located along central berm (view southwest)

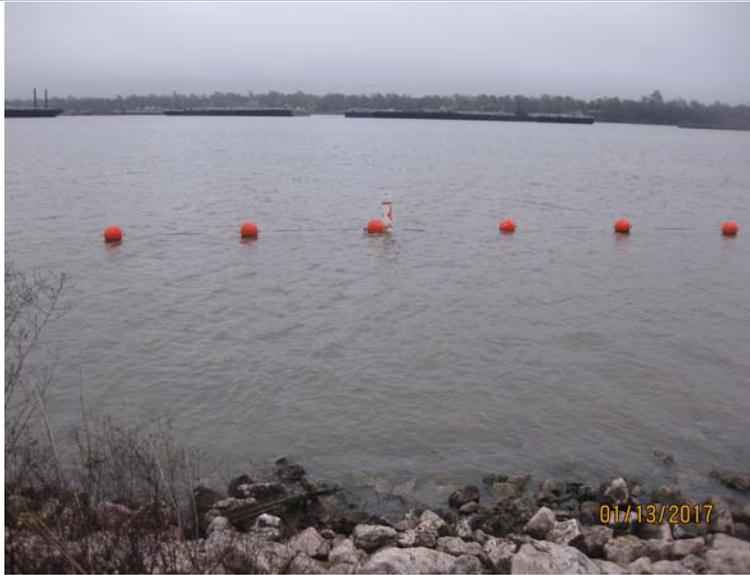
Photograph 09: Warning buoys along northern edge of armor cap (view north)

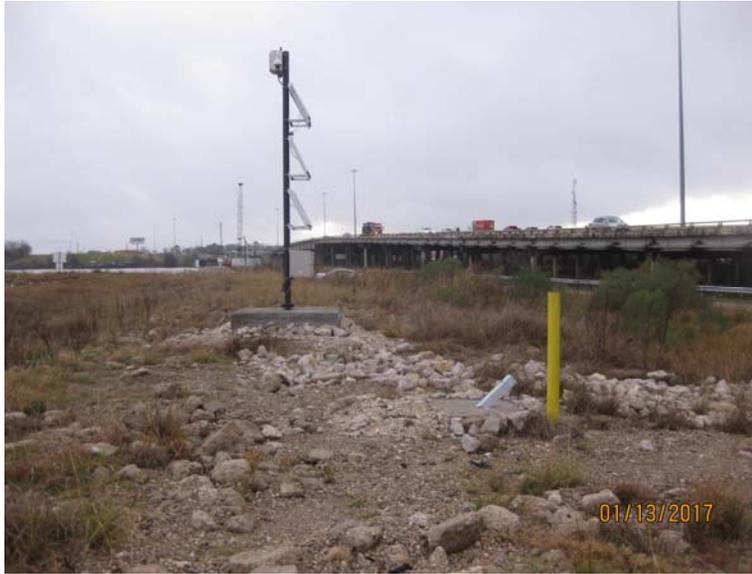
Photograph 13: Security camera system located on western portion of southern berm (view east)

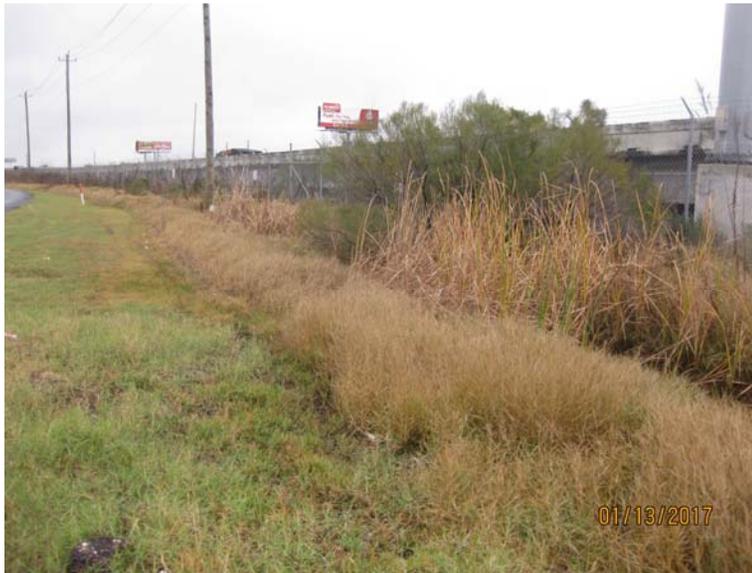
Photograph 15: Perimeter fence located south of I-10 on west bank (view west)

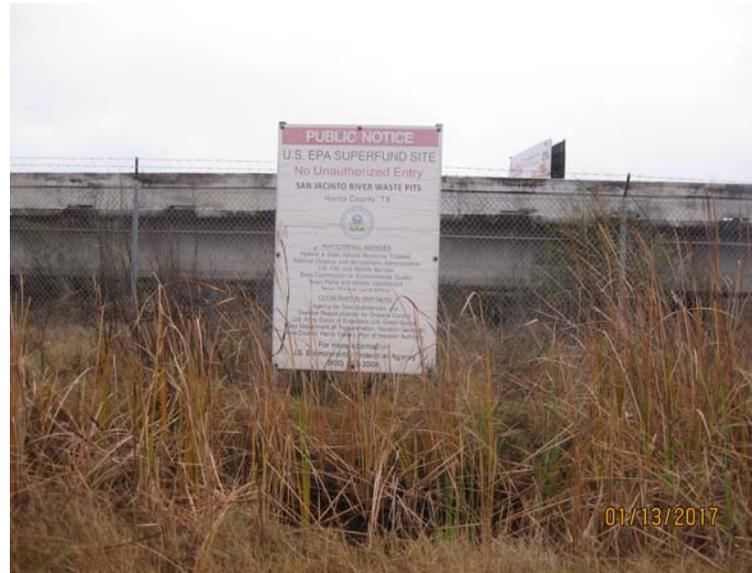
Photograph 16: USEPA Public Notice Sign located south of I-10 on west bank (view north)

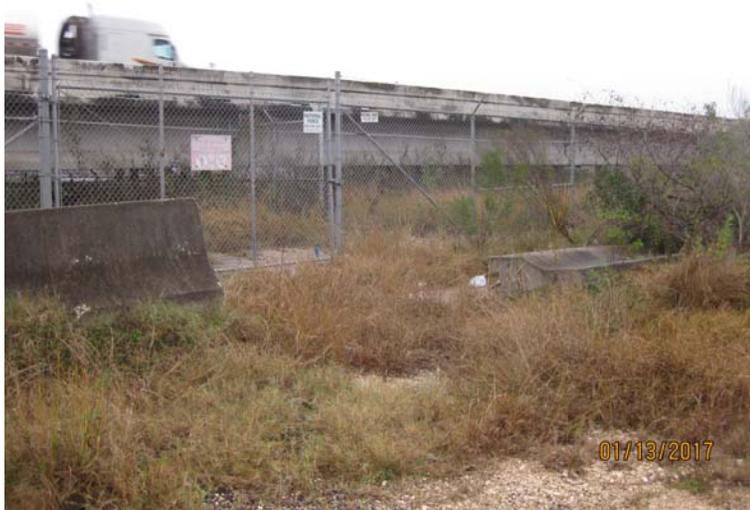
Photograph 17: Perimeter fence located south of I-10 on west bank (view northeast)

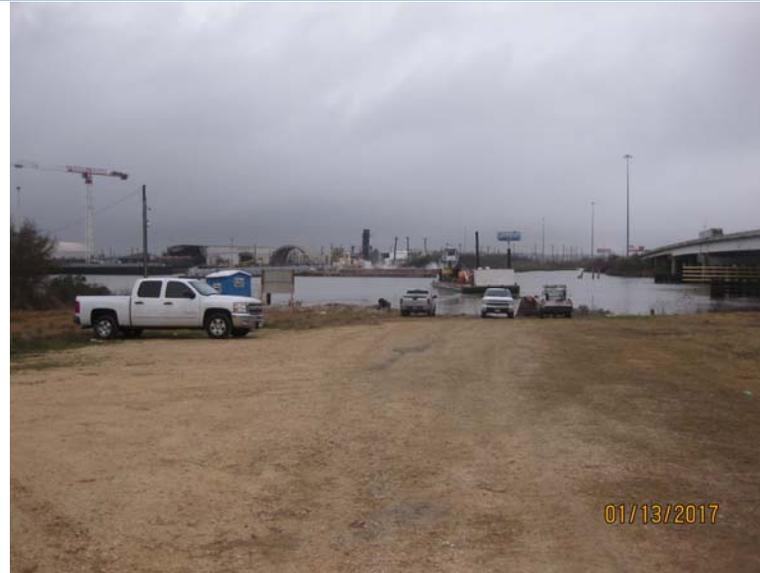
Photograph 18: Construction activities observed inside area south of I-10 on east bank (view west)

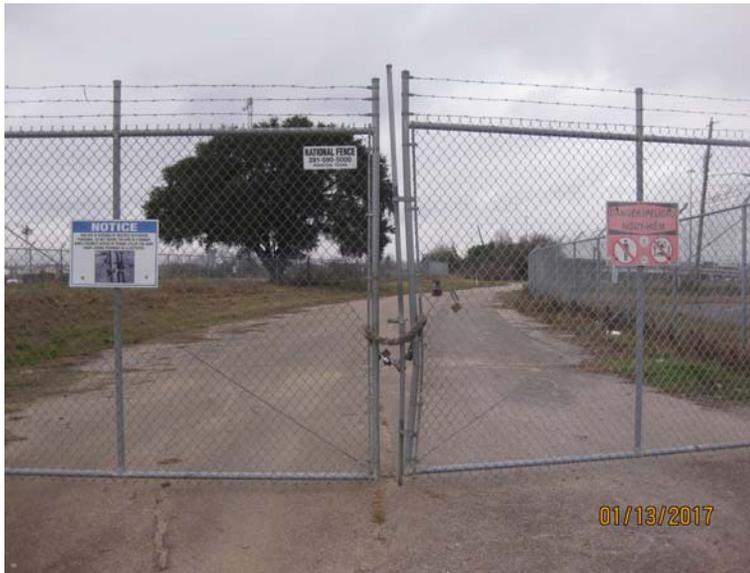
Photograph 19: Signage and access gate located south of I-10 on east bank (view west)

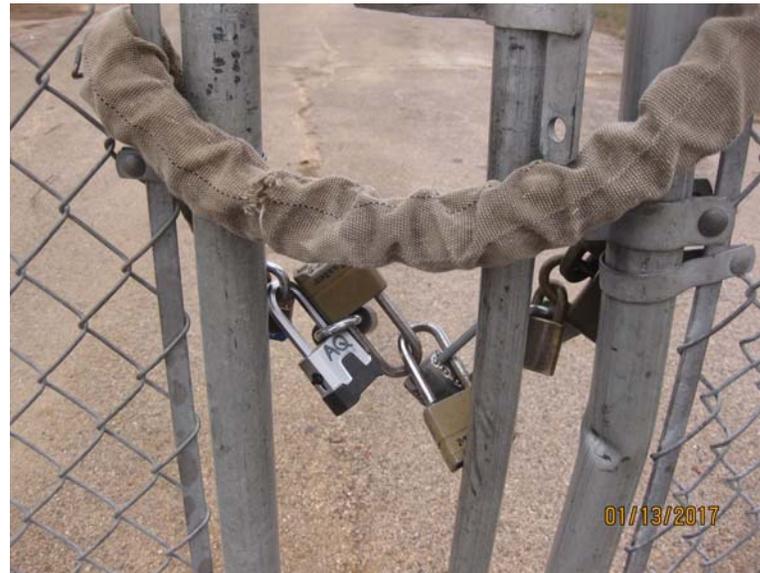
Photograph 20: Close-up view of replaced lock on access gate located south of I-10 on east bank

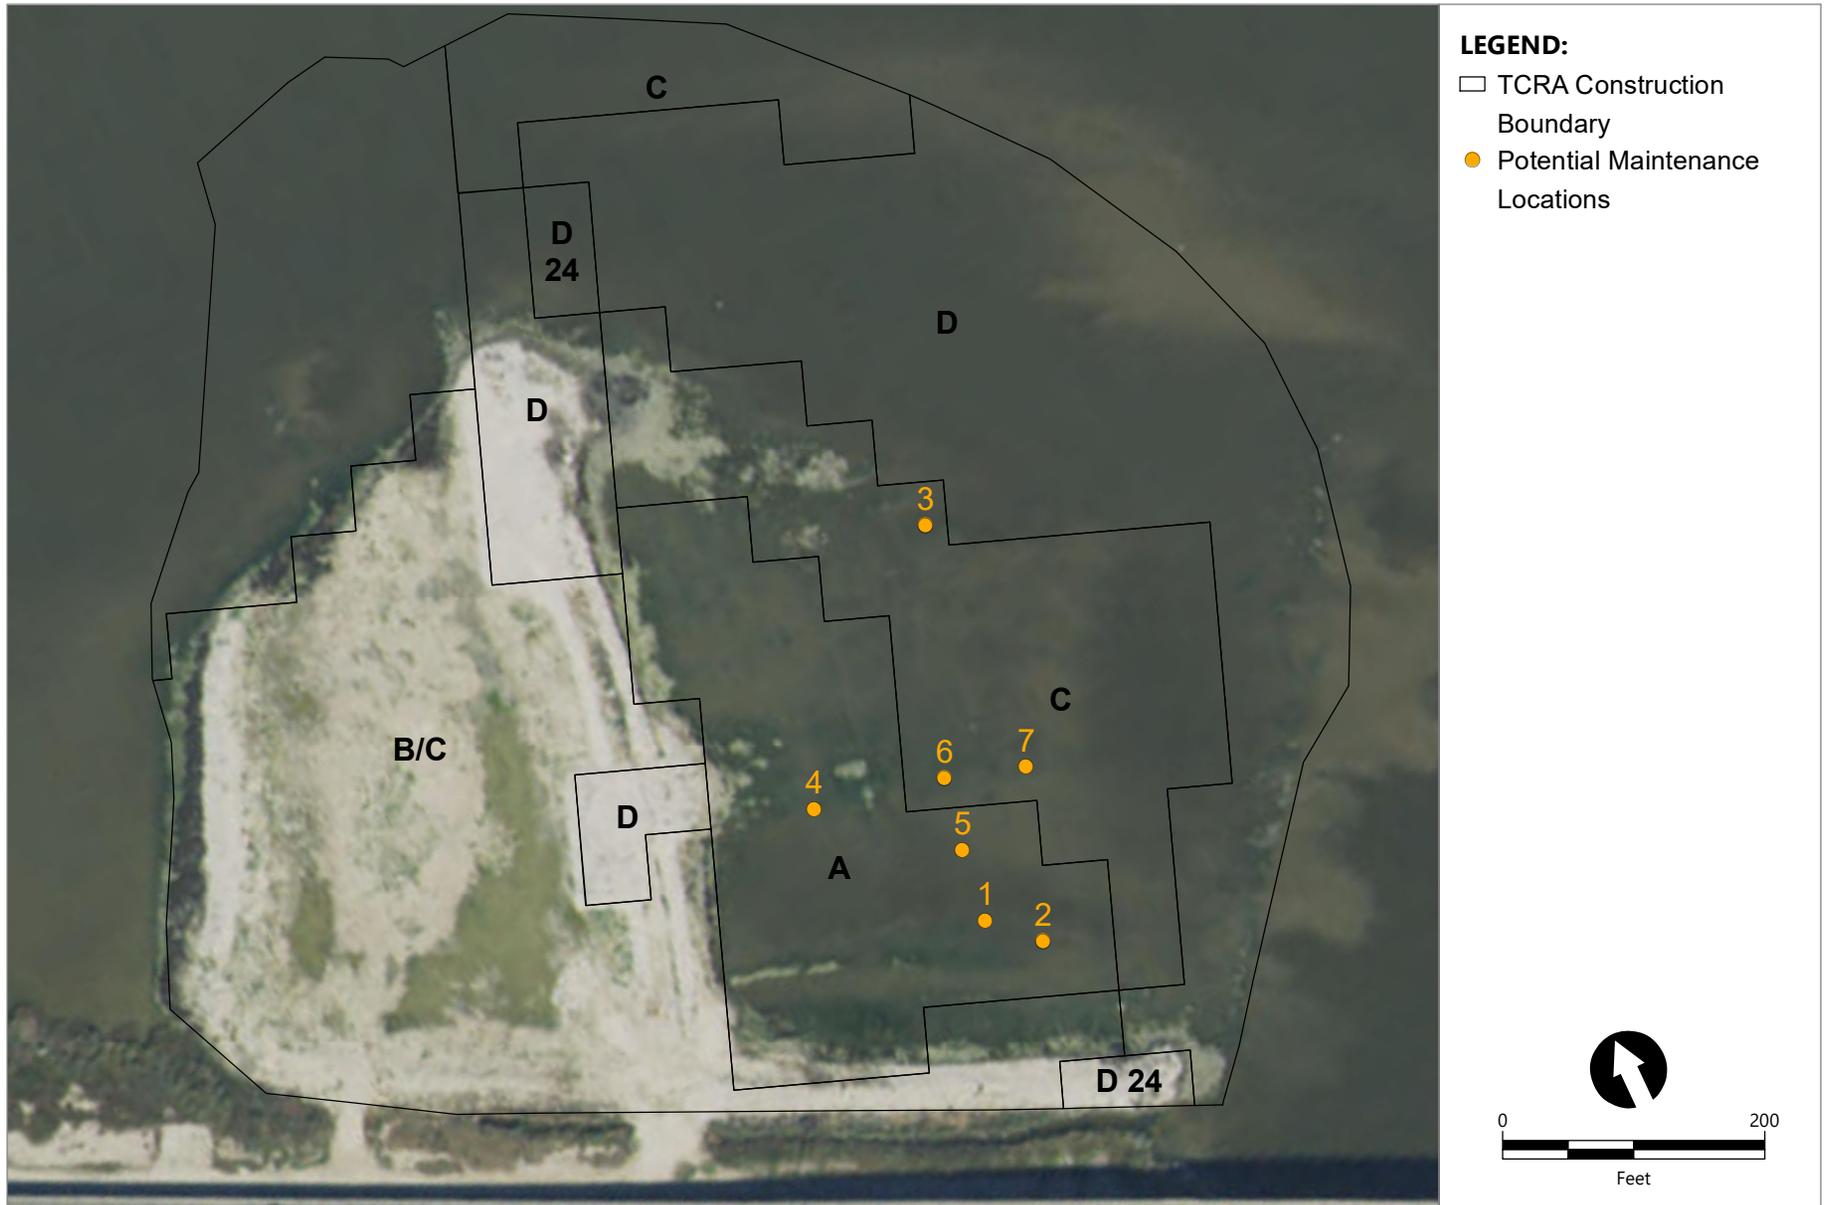
Figure 1
January 2017 Potential Maintenance Locations
San Jacinto River Waste Pits

During that inspection, the tides were extremely low, providing an opportunity for visual inspection of areas that are typically inundated. The team identified potential maintenance areas where visible geotextile was found at seven small areas in the eastern cell (see Figure 1). Locations of each of these areas are provided in Table 1, and shown in Photographs 1 through 7. Probing will be conducted at all areas and rock will be placed, if necessary, to ensure the minimum 1-foot thickness of cap material is present at each location.

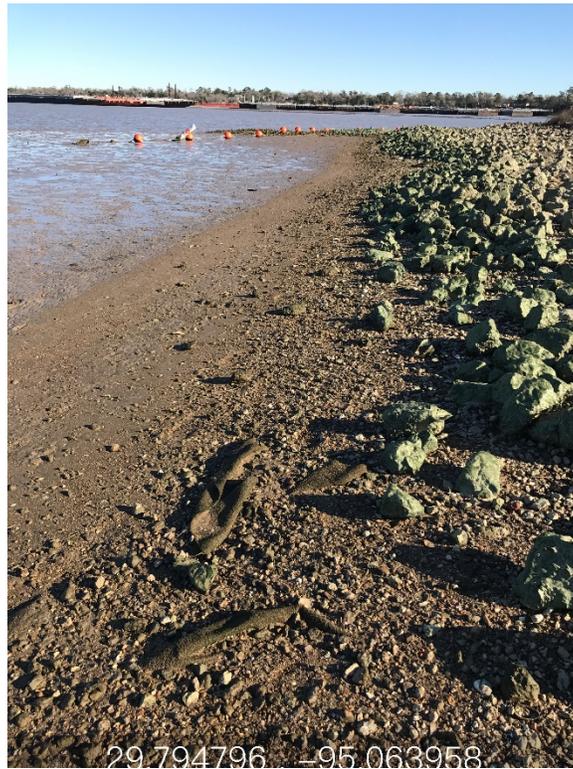
In addition to the areas shown in Figure 1, there were several locations of visible geotextile noted along the western edge of the Time Critical Removal Action (TCRA; Photograph 8). This visible geotextile appears to be excess material at the edges of previous maintenance areas and at the edge of the armored cap. Additional rock will also be placed in areas that are shown to have adequate rock where there is geotextile overlap from previous maintenance events for aesthetic purposes, even if adequate armor is found beneath the visible geotextile.

Photograph 8 – Example Visible Geotextile along Western Edge of TCRA, Looking North

As stated above, there were also several locations of visible geotextile observed along the western edge of the armored cap on January 23, 2017; this visible geotextile was determined to be excess material at the edges of previous maintenance areas and at the edge of the armored cap. Additional rock was placed in those areas for aesthetic purposes.

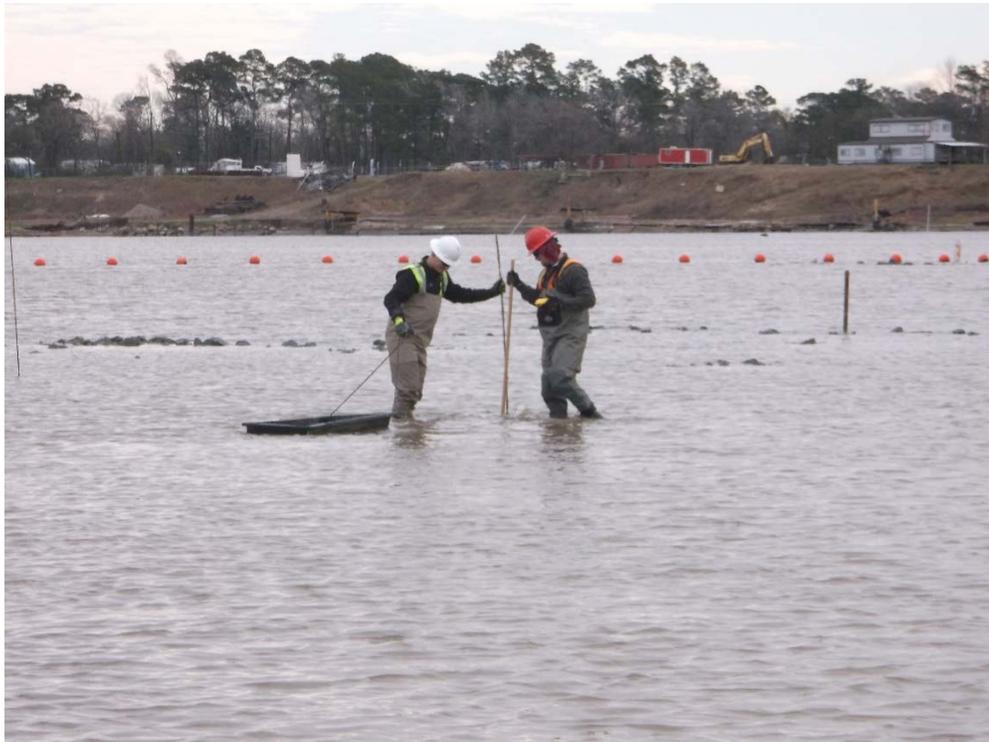
Photograph 1: BESI probing a maintenance location in preparation for repairs.

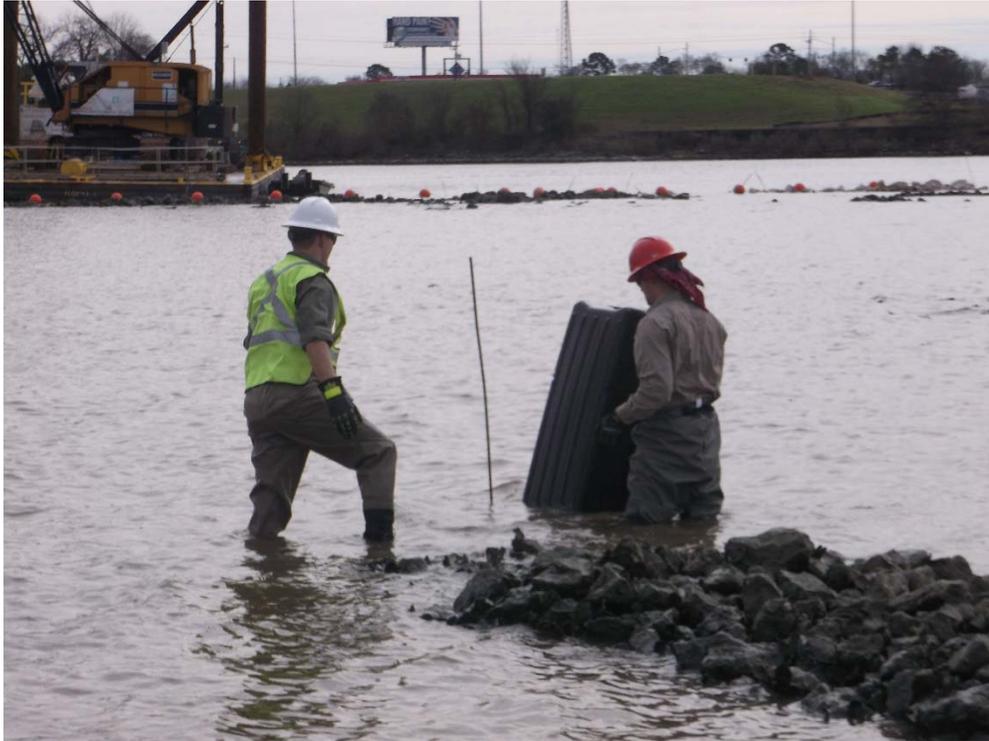
Photograph 2: Placing C rock on maintenance location 3.

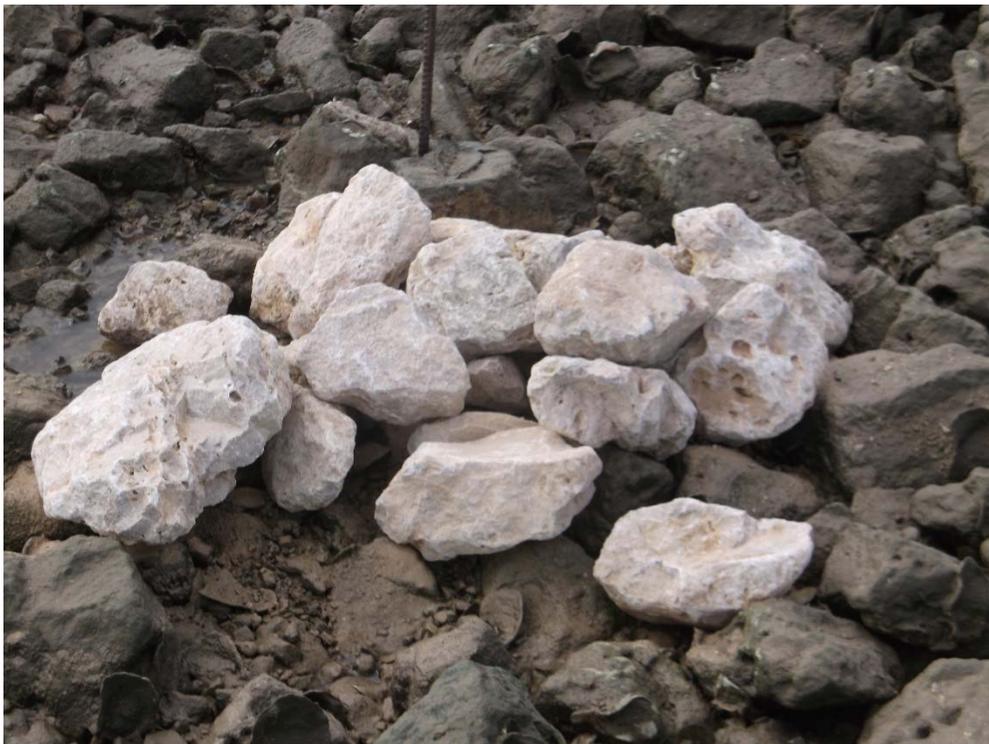
Photograph 3: View of maintenance area 6 after repair.

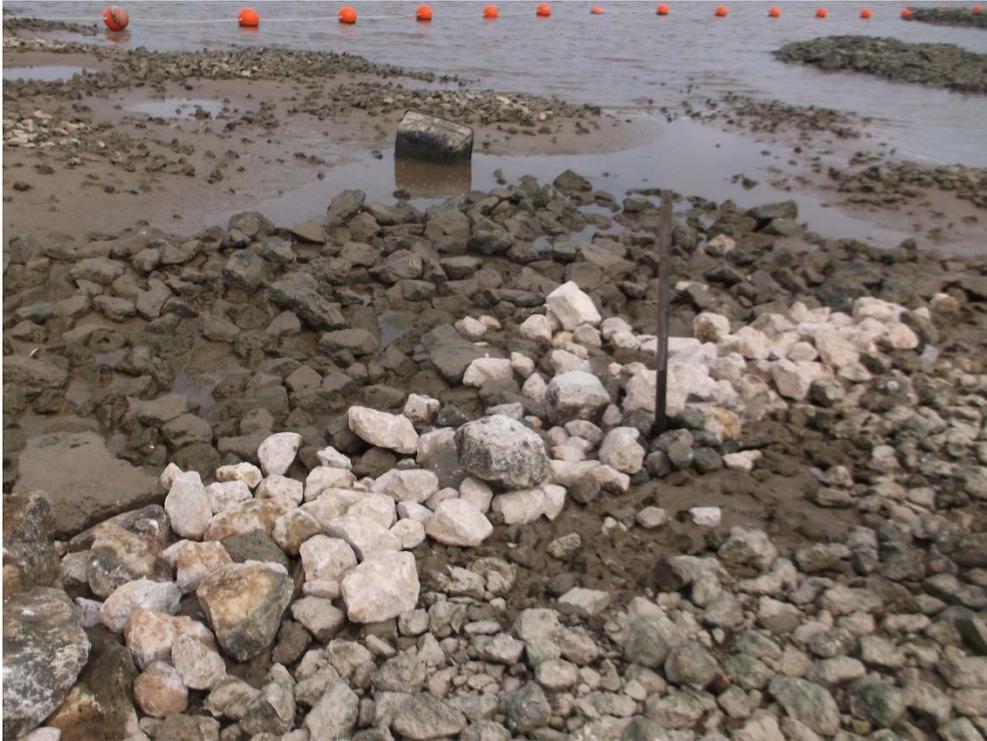
Photograph 4: View of a western cell location after rock placement.
